Manhole Inspection Summary

Manhole # S41C__052MH

Inspection ☐ Is Incomplete Rating: **3) Fair**

Location Address: **246 dallas ct**

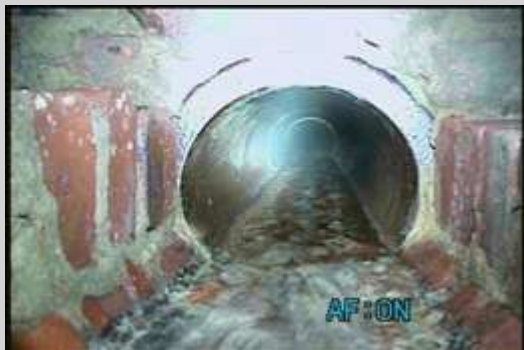
12 O'Clock Outflow

8 in. Circular Gravity Sewer
Pipe Out @ 12 O'Clock

Pipe Material: **Clay** ☐ Pipe Lined

Invert Depth: 11.35 (ft.) Flow Characteristics: **Fast**

Deposits: ☒ None ☐ Mud ☐ Sludge ☐ Debris ☐ Grease

Infiltration: **None** Pipe Seal Cond: **Unknown**

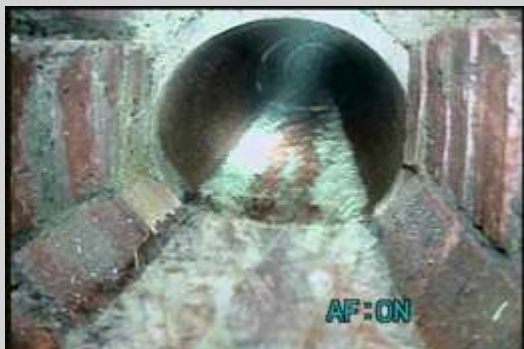
6 O'Clock Inflow

8 in. Circular Gravity Sewer
Pipe In @ 6 O'Clock

Pipe Material: **Clay** ☐ Pipe Lined

Invert Depth: 11.33 (ft.) Flow Characteristics: **Fast**

Deposits: ☒ None ☐ Mud ☐ Sludge ☐ Debris ☐ Grease

Infiltration: **None** Pipe Seal Cond: **Unknown**

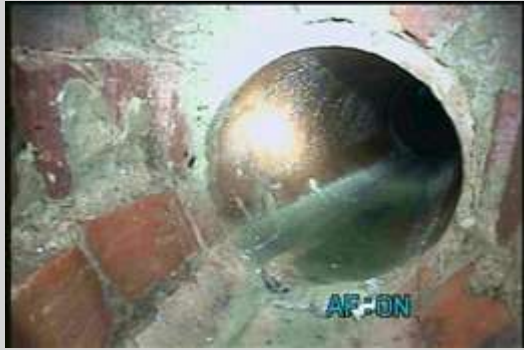
9 O'Clock Inflow

8 in. Circular Gravity Sewer

Pipe In @ 9 O'Clock

Pipe Material: **Clay** ☐ Pipe Lined

Infiltration: **None** Pipe Seal Cond: **Unknown**
